# MILL CREEK/ROCKY FLATS FISH PASSAGE PROJECT

Impact Report  
Prepared for the Lyndhurst Foundation  
By  
The Nature Conservancy in Georgia  
February 25, 2020

## Sections II/III. Narrative Summary and Evaluation

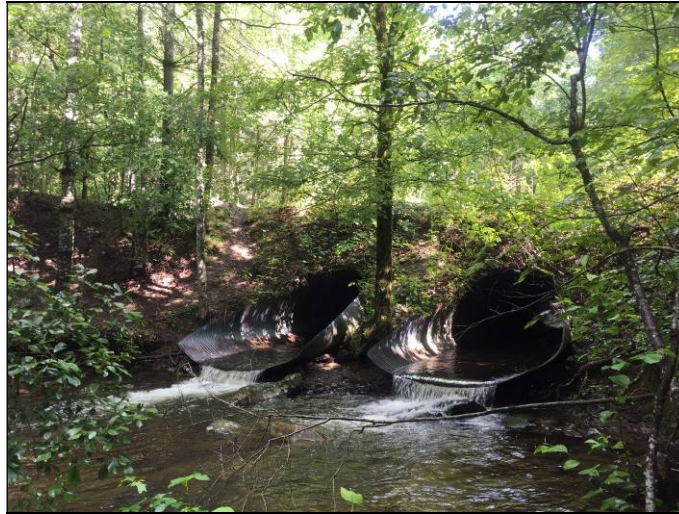
*Fig. 1. Baseline: Two perched culverts, with the one on the right collapsed in the center. By the time we started construction the collapse had blocked all flow through that culvert and there was significant scour downstream.*

The United States Fish and Wildlife Service (USFWS) Southeast Fish Habitat Team removed the two failing pipe culverts on September 5, 2019. On September 10, 2019, volunteers from The Nature Conservancy and the U.S. Forest Service worked with the USFWS crew to assemble the new culvert, screwing in hundreds of nuts and bolts. The crew finished installing the new Contech Aluminum Box Culvert on September 23, 2019.

This project also stabilized sediment that was previously washing into Mill Creek as a result of the sinkhole created by the collapsed culverts. Mountain stream habitats, like Mill Creek, are highly sensitive to sedimentation which can have a number of direct and indirect effects on aquatic communities. Direct effects can range from loss of spawning sites to gill clogging, while indirect effects include loss of habitat through homogenization and even oxygen depletion. This habitat homogenization, which ultimately leads to homogenization of fish assemblages, is a key threat to these watersheds and the highly specialized species that rely on the habitat diversity of the Upper Conasauga Watershed. Diffuse sediment inputs, like that of Rocky Flats, degrade stream ecosystem function which is why reduction of sedimentation is listed numerous times throughout the Georgia State Wildlife Action Plan as a high priority conservation action.

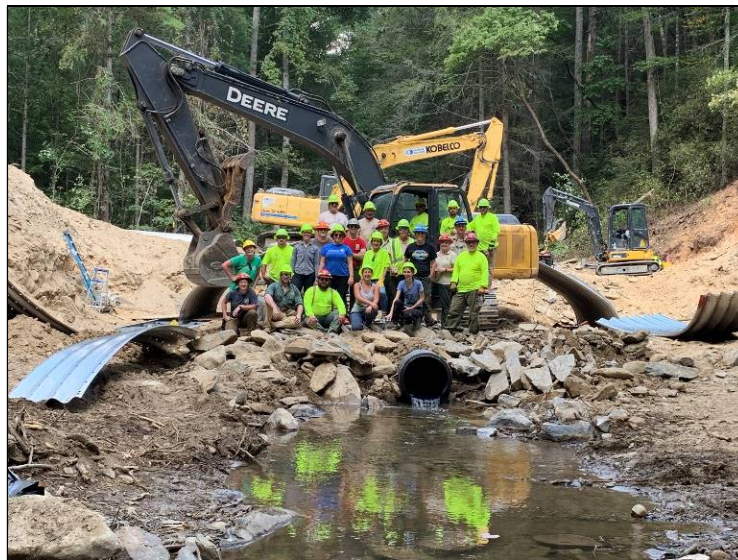
*Fig. 2. Staff from USFWS, USFS, and TNC gathered to help assemble the new bottomless culvert. This workday was a great way for people to contribute to the project and gave many a chance to see the site for the first time.*

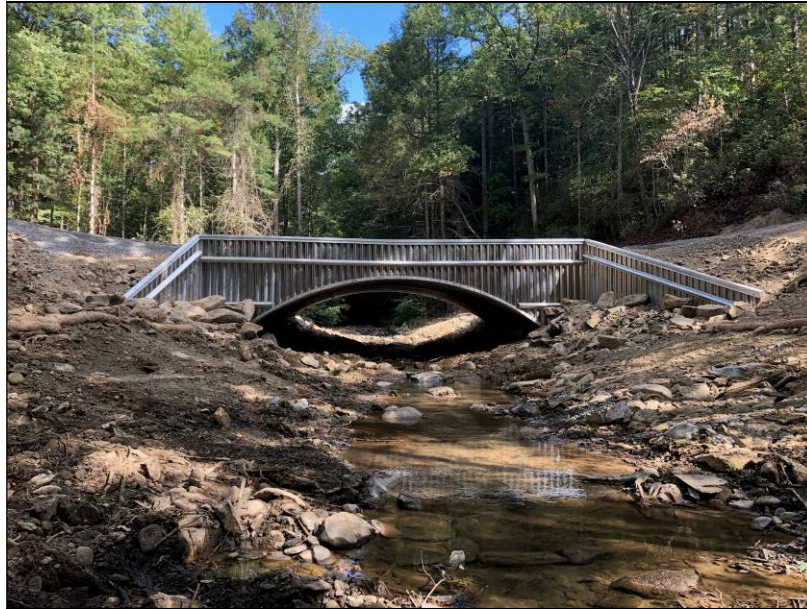
*Fig. 3. September 23, 2020 - Immediately after installation was complete.*

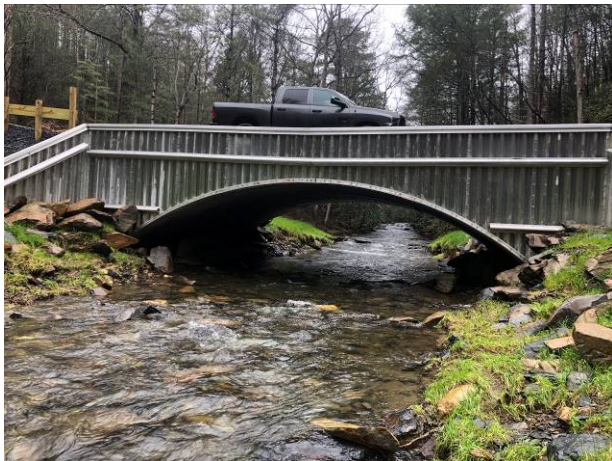
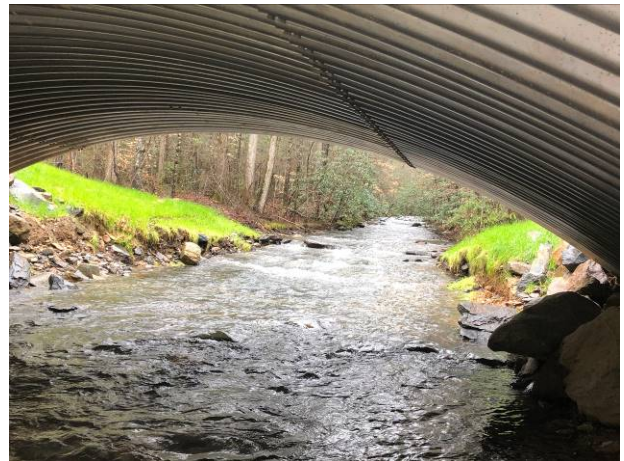
*Fig. 4. February 20, 2020 - Mill Creek and Rocky Flats crossing.*
